Smoke and Dye Testing Summary

High Level Sewershed

Test ID	Test Type	Date Inspected	Company / Super.	Blower MH	Ground Condition	Notification Made?	Total Length
S1028-267	Smoke	9/2/2009	ADS/TM	S11MM1006MH	Dry	Yes	595.10

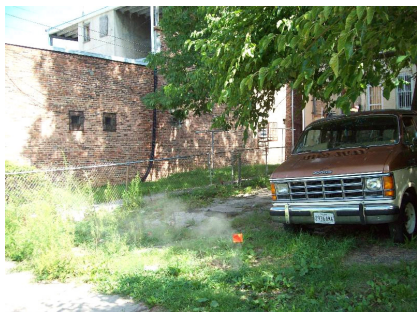
Picture \S1028-267-OB01-P01.jpg

Source Cleanout

Location Yard - back

Comments Smoke from cleanout in back yard. 4746 Park Heights Ave.

Comments Back of house, 4746 Park Heights Ave.

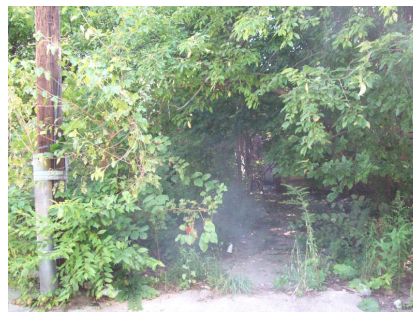
Picture \S1028-267-OB02-P01.jpg

Source Cleanout

Location Paved concrete

Comments Smoke from cleanout in paved concrete behind house. 4738 Park Heights Ave.

Comments Back of house, 4738 Park Heights Ave.

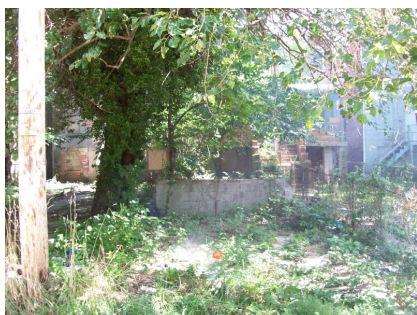
Picture \S1028-267-OB03-P01.jpg

Source Cleanout

Location Yard - back

Comments Smoke from cleanout in back yard. 4730 Park Heights Ave.

Comments Back of house, 4730 Park Heights Ave.

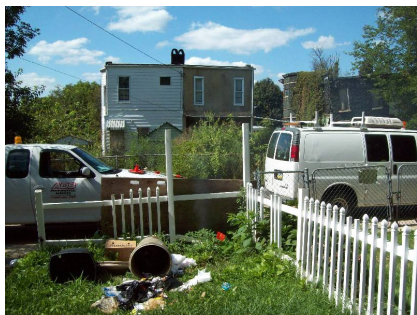
Picture \S1028-267-OB05-P01.jpg

Source Cleanout

Location Yard - back

Comments Smoke from cleanout in back yard. 4718 Park Heights Ave.

Comments Back yard, 4718 Park Heights Ave.

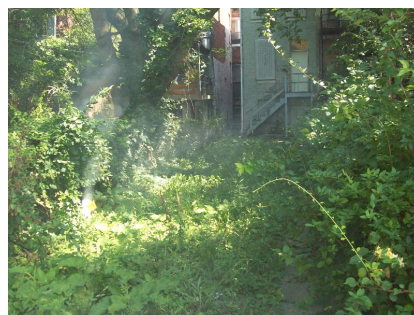
Picture \S1028-267-OB04-P01.jpg

Source Cleanout

Location Yard - back

Comments Smoke from cleanout in back yard. 4726 Park Heights Ave.

Comments Back of house, 4726 Park Heights Ave.

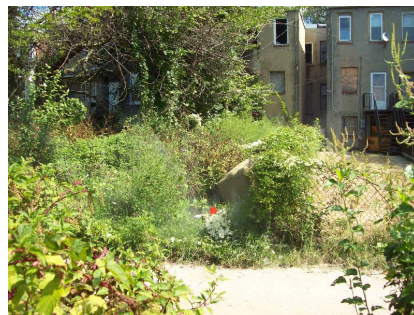
Picture \S1028-267-OB06-P01.jpg

Source Service Lateral

Location Yard - back

Comments Smoke from service lateral in back yard. 4710 Park Heights Ave.

Comments Back of house, 4710 Park Heights Ave.

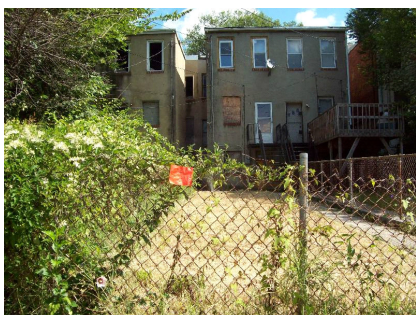
Picture \S1028-267-OB07-P01.jpg

Source Cleanout

Location Yard - back

Comments Smoke from cleanout in back yard. 4708 Park Heights Ave.

Comments Back of house, 4708 Park Heights Ave.

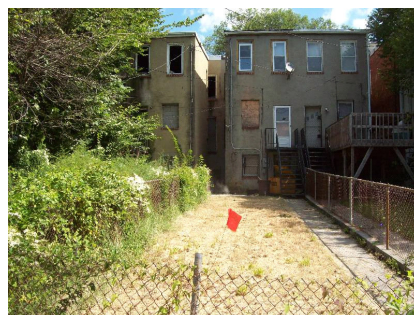
Picture \S1028-267-OB08-P01.jpg

Source Service Lateral

Location Yard - back

Comments Smoke from service lateral in back yard. 4708 Park Heights Ave.

Comments Back of house, 4708 Park Heights Ave.

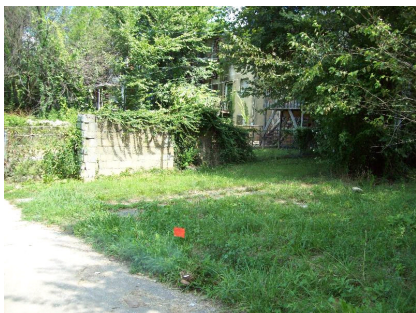
Picture \S1028-267-OB09-P01.jpg

Source Cleanout

Location Yard - back

Comments Smoke from cleanout in back yard. 4702 Park Heights Ave.

Comments Back of lot, 4702 Park Heights Ave.
